AREA	BMW	Plant:	TUPELO USA
KAIZEN THEME	Incision Left on Lower Side Panel

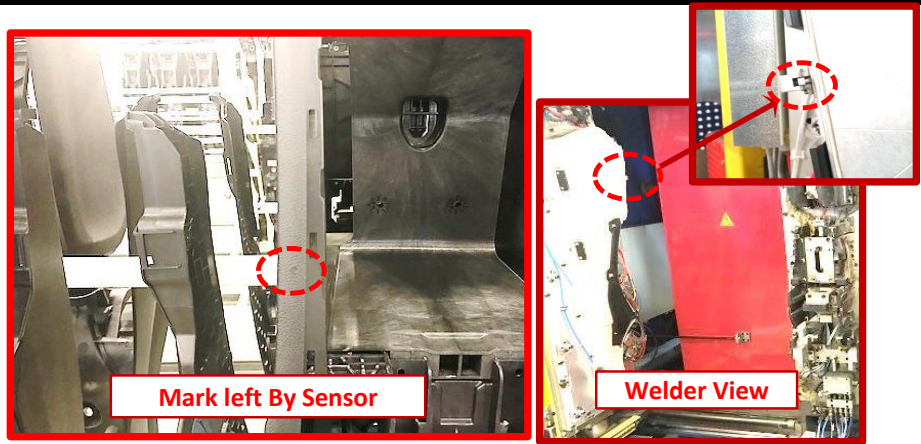
Before Kaizen Description:	Incision mark caused by sensor at BMW hot plate welder 2A. Resulting in customer complaints and sorting activities
-----------------------------------	--
